Manhole Inspection Summary

Manhole # S53C__002MH

Location Address: **3333 e fayette st**

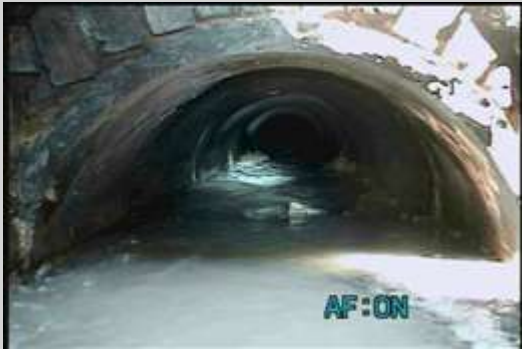
12 O'Clock Outflow

24 in. Circular Gravity Sewer
Pipe Out @ 12 O'Clock

Deposits: ☒ None ☐ Mud ☐ Gravel ☐ Debris ☐ Grease

Infiltration: **None** Pipe Seal Cond: **Unknown**

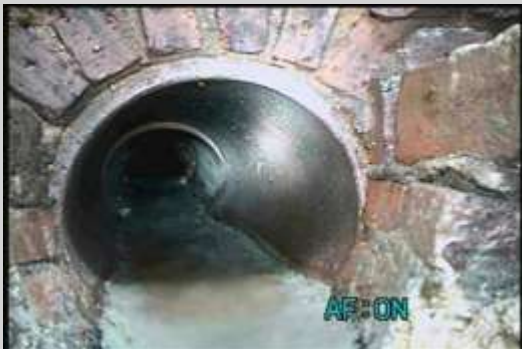
3 O'Clock Inflow

12 in. Circular Gravity Sewer
Pipe In @ 3 O'Clock

Infiltration: **None** Pipe Seal Cond: **Unknown**
